Radiation Safety issues for the PF-AR in KEK

H. Nakamura, S. Ban, K. Iijima, Y. Namito and K. Takahashi

High Energy Accelerator Research Organization(KEK), 1-1 Oho, Tsukuba-shi, Ibaraki-ken, 305-0801, Japan

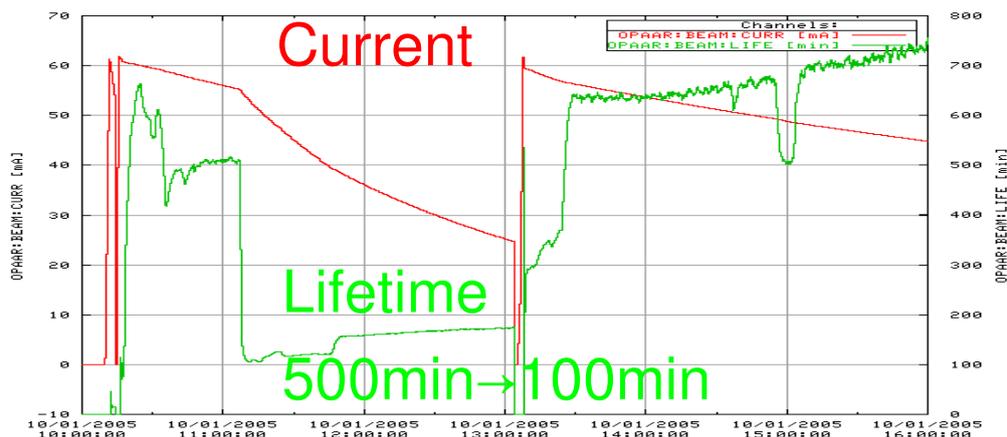
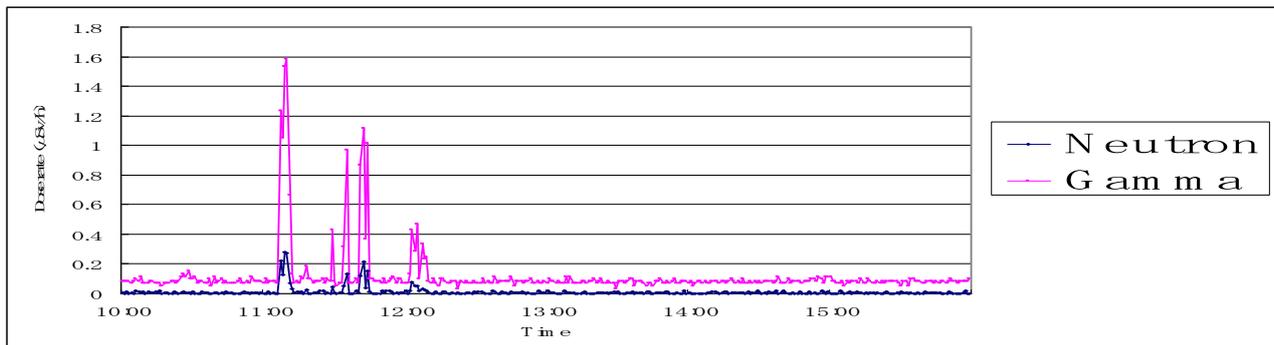
Usual ambient dose rate in the experimental halls is background level. However, the dose rate increases when the beam lifetime of the PF-AR decreases suddenly. Figure 5 shows a typical example of the incident occurred at the NW12 beam line in the North West experimental hall. When the beam lifetime decreased from 500 minutes to 100 minutes, the gamma dose rate at ORG0509 monitor increased from 0.1 $\mu\text{Sv/h}$ to 1.6 $\mu\text{Sv/h}$ and the neutron dose rate increased from 0 $\mu\text{Sv/h}$ to 0.2 $\mu\text{Sv/h}$. At that time, ORG0509 monitor was located at the wall of the experimental hall, therefore, there was little information about the dose rate around the beam line.

Measurement of residual radiation from the beam duct of the ring showed the duct near the steering magnet of NW12 was activated. This phenomenon is considered bremsstrahlung due to dust trapping near the duct[3].

Fig.5 - An example of the sudden beam lifetime decreasing and increase of the dose rate at the ORG0509 monitor in the experimental hall.

The followings were first things what we did for the safety in the experimental hall. We set up the area where people were not allowed to enter because of high dose rate. We changed temporarily the alarm level of the ORG monitors in the experimental halls from 20 μ Sv/h to 1 μ Sv/h for detecting the incidents occurred far from the monitors.

Next, lead blocks were installed in the optic hutch of the NW12.

An ionization chamber for interlock was installed out of the optic hutch. It closes the MBS when the dose rate exceeds 5 μ Sv/h and continues for 3 minutes.

Finally, ORG0509 monitor was moved to near the optic hutch of the NW12 for detecting radiation effectively.

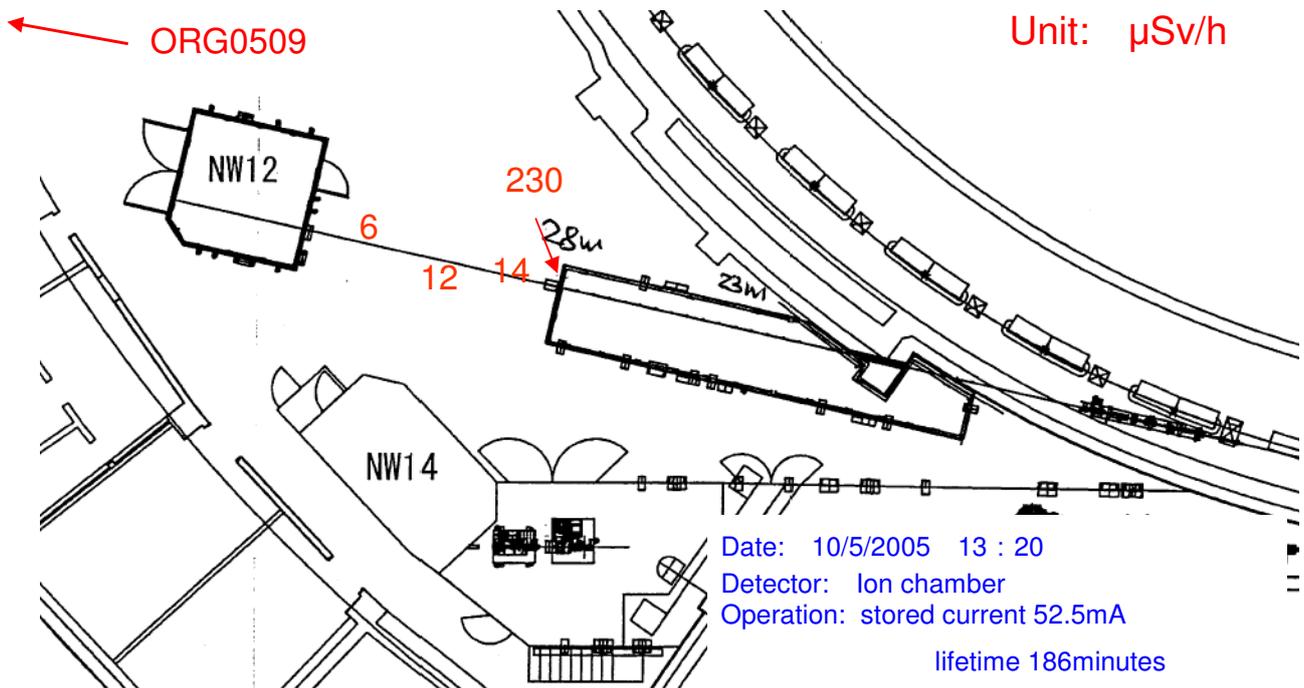
When another similar incident happened, we measured the dose rate around the NW12 with survey meters. Figure 6 shows the dose rate around the NW12. The maximum dose rate at the surface of the NW12 hutch was 230 $\mu\text{Sv/h}$.

The measurements showed the following conditions for the incident. Changing narrowly the gap of NW14 insertion device which located upper stream of NW12 often triggered the incident. The vacuum level was worse. The beam lifetime decreased. The dose rate around the NW12 increased, however not increased around other beam lines. The dose rate returned to background level when the main beam shutter (MBS) in the beam line was closed.

Fig.6 - The dose rate around the beam line NW12 during the beam lifetime decreasing.
