THE FLYING GAS BOTTLE

M. Bieler, DESY, Hamburg, Germany

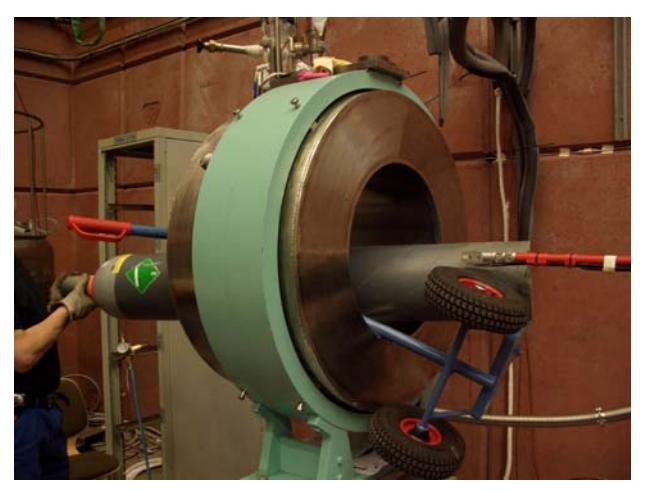
Figure 1: The bottle inside the magnet.

He stumbled, the gas bottle got nearer to the magnet than foreseen and was attracted by the magnet.

The flying gas bottle pressed the safety officer against a hard object. He received a laceration on the forehead and a black eye.

Figure 1 shows the magnet just after the accident. The bottle and the trolley are sticking inside the magnet aperture. Fortunately the bottle was not damaged. At this time the magnet is being ramped down. Someone holds the bottle to prevent it from falling out of the magnet. The red rod on the right side of the picture carries the magnetic measurement device, which was destroyed by the bottle.

The main cause of the accident was the stumbling of the safety officer, caused by pressure of time to avoid a quench of the magnet.

- The pressure reading of the helium supply was out of order. This created the hectic rush to avoid the quench.
- The cryogenic system was located behind the magnet, so that the gas bottles had to pass by the magnet.
- One gas bottle carried two different labels.

- The test area was modified in a way that the helium bottle was placed at the entrance of the area.
- Inside the test area the region where magnetic fields above 300 Gauss are possible was marked with an additional chain. All employees working in this area were instructed about the relevance of this chain.

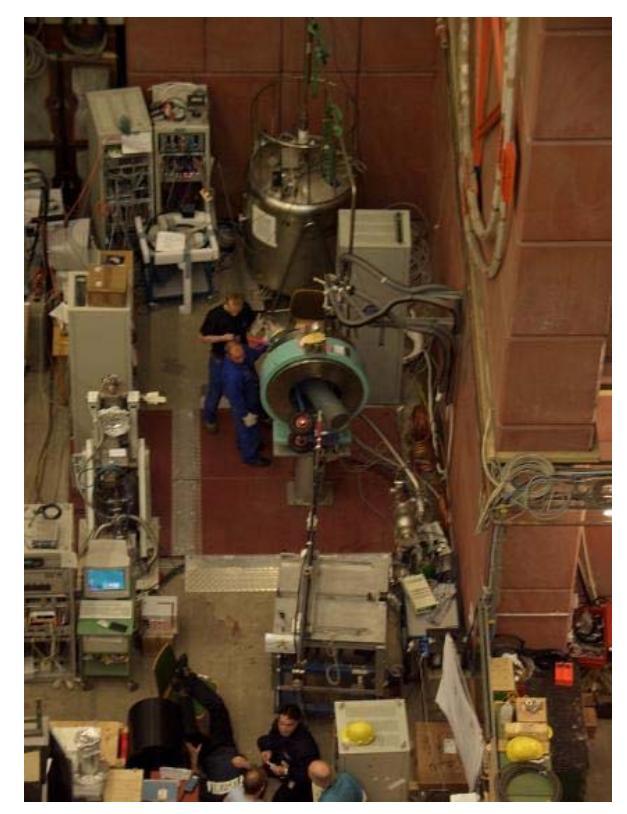
Figure 2: The test area right after the accident.

Figure 2 shows the whole test area, with the gas bottle still sticking inside the magnet. The entrance to the test area is in the foreground, the cryogenic system is located at the wall behind the magnet.
