#### 14th ESLS RF Workshop

### **ELETTRA SYNCHROTRON RADIATION LIGHT SOURCE**

### **BOOSTER RF Plant**

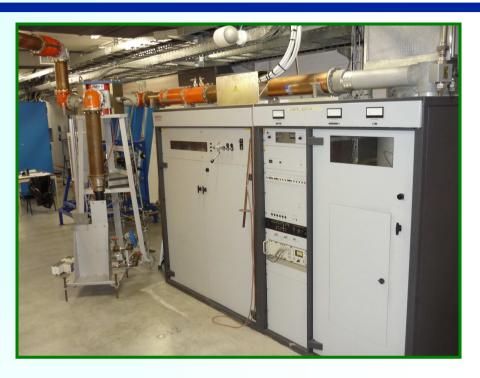
### 5 cells cavity (PETRA type)

Cavity voltage 40 to 600 kV; 3 Hz linear ramp

Klystron based Transmitter; 60 kW cw, heater's hours 84430

Troubles, but no user down time after two years of operation on LLRF. An EMC shield has been installed around the drive card of the stepper motor's.

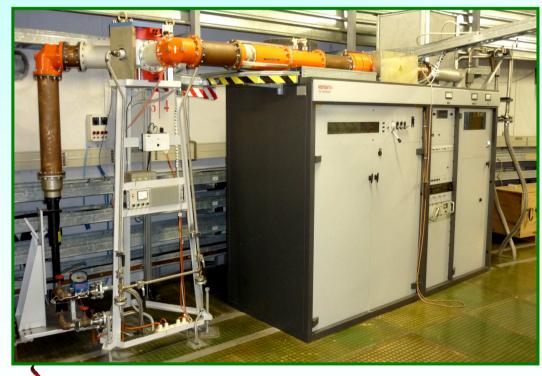
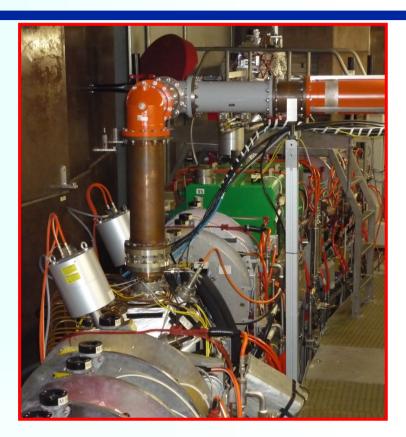
- ✓ 4 single cell ELETTRA cavities
- ✓ 3 Klystron based transmitters 60 kW average heater's hours: 97740

Klystron's replacement in three transmitters from April 2009 to January 2010.

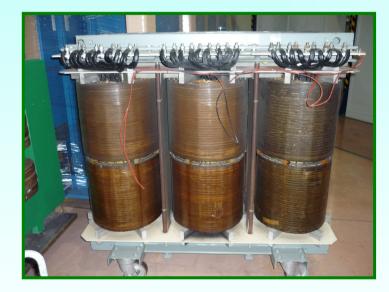
**188 kVA 3phase transformer for this transmitter: one unit damaged during transportation from Storage ring to Booster in 2007... try to repair it !!!**

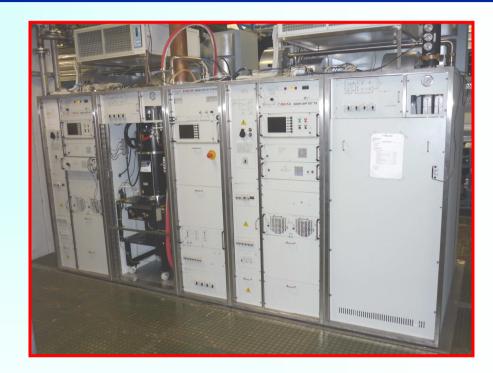
### **RF Plant #9**

### **IOT- based transmitter:**

- installed Jun-2006 (TH 793); 6 months commissioning; on cavity since Jan-2007
- two transmitters Tx-A and Tx-B of 80 kW/each; when combined: 150 kW RF

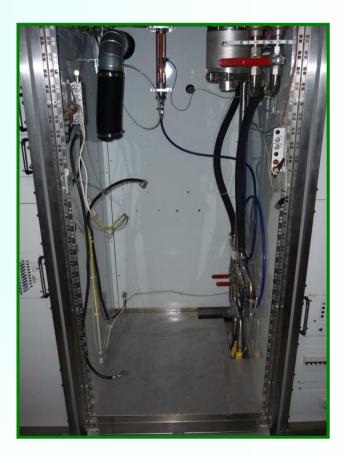
- ✓ The space available for the E2V input circuit could not be widened
- ✓ Several modifications to Electrosys Tx-A transmitter needed to host the E2V tube:
  - new output coax line
  - -custom output coax elbow
  - lay-out of the cooling pipes re-arranged
  - new parameters for thresholds & interlocks
  - "knob" to raise manually the HV of the tube at the first start up (min. 22 kV)

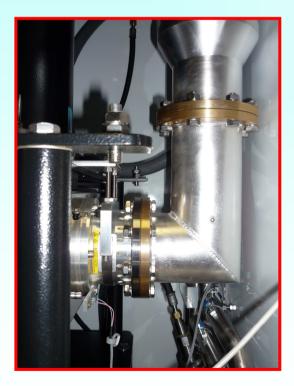
# The E2V input circuit FITs exactly the cabinet (5 mm left)!
