Paul Scherrer Institut Lukas Stingelin for the PSI rf-group

RF developments at PSI

14th ESLS RF Workshop, ELETTRA / Trieste, Italy / 29-30 September 2010

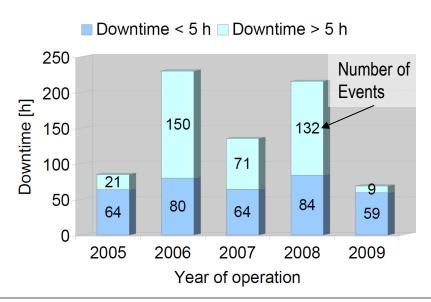
Availability:

• Average 2004-2009: 97%

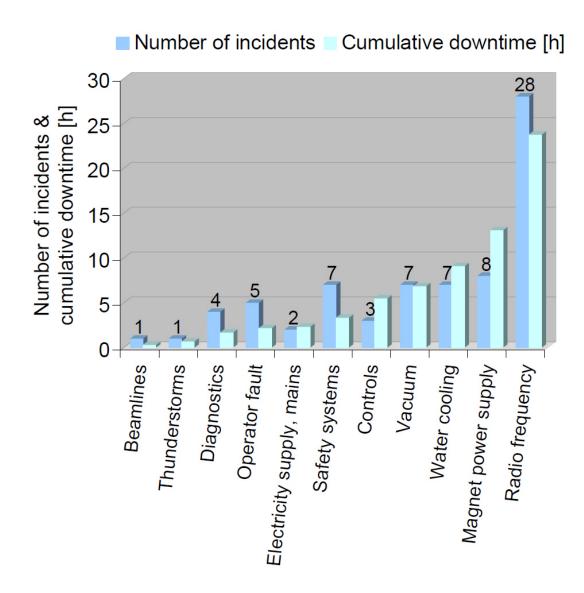
Faillures per System in 2009

Major events:

- Water leak at cavity HOMFS flange
- 20% of beam dumps due to arc detector interlocks

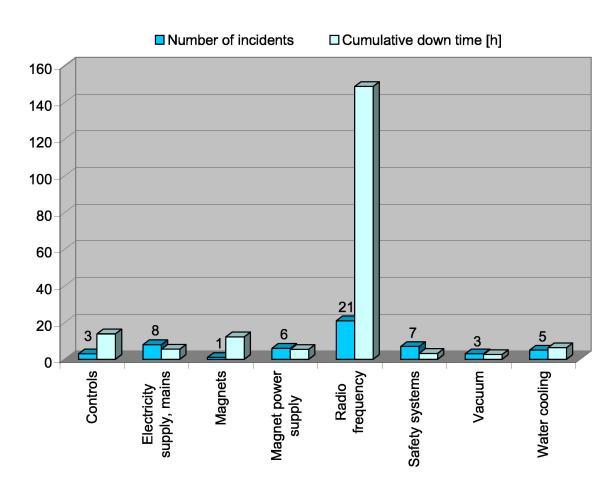
RF faillures in 2010

Major events:

Cryogenic plant of S3HC

- 100h down time due to contamination of heat exchanger
- 35h down time due to trip of helium compressor
- +6h down time due to trip of helium compressor

LINAC:

- 4.5h down time due to defective HV-cable from Charging-Unit to PFN.
- 12h down time due to water leak at Solenoid magnet.

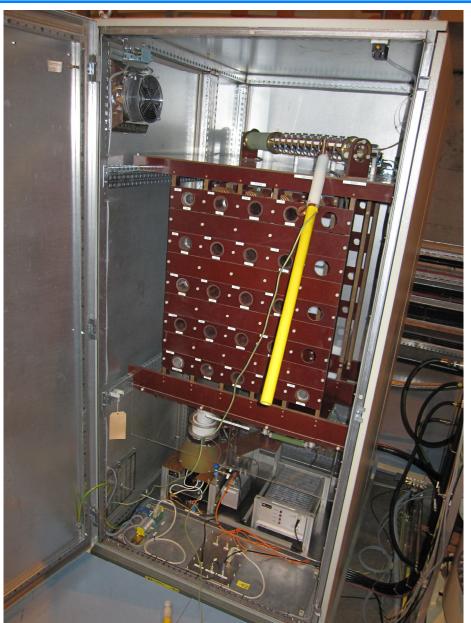
SLS-LINAC Problems and Upgrades

- Thyratrons heating filament broken.
- Spare Thyratron had "self triggering" problem.
- □ CX1836A Adapted to CX1836AP-Type (long hold time), but did not really improve.
- ✓ PFN Capacitors were leaking oil. Had been replaced.
- ✓ PFN retuned at low voltage.
- ✓ High-voltage cable had short circuit and was replaced.

- ☐ Fire detection and protection of PFN is under investigation.
- Water leaks at LINAC: Solenoid coils had to be glued.
- ☐ Maybe, solenoids will be replaced in future.

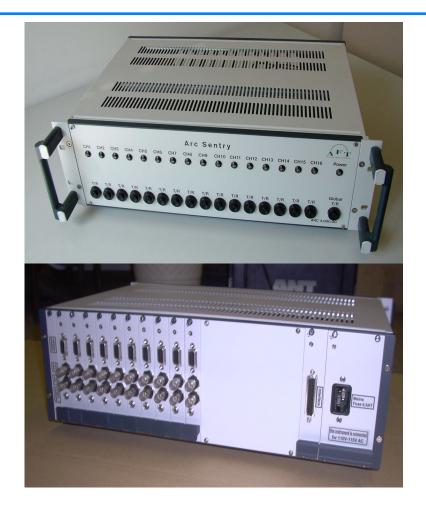
New Coincidence Arc Detectors

- ✓ Installed during April 2010 shutdown for circulator (Additional arc view-port installed)
- ✓ Installed during August 2010 shutdown for klystron (Additional arc view-port installed at coaxial output-line of klystron)
- ➤ Since April 2010: 1 false arc registered at circulator (no beam-dump)
- ☐ Planned to upgrade the reminding 3 SR-RF plants

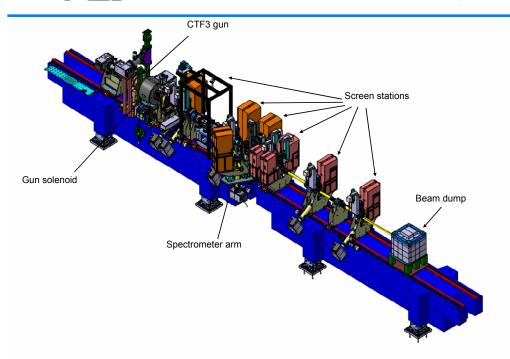
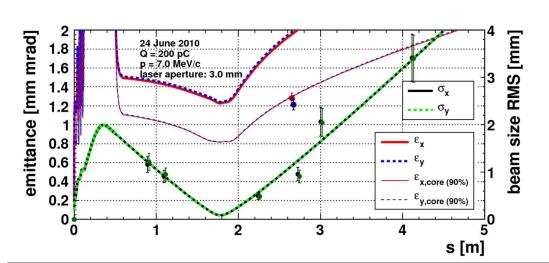
SwissFEL 250MeV Injector Commissioning Phase 1

RF Gun:

- •CTF3 gun V (CERN)
- 2.6 cell standing wave S-band
- Nominal gradient 100 MV/m
- 21 MW peak power, 2.0 µs pulse length
- 10 Hz repetition rate
- Circulator from AFT, Waveguides from IHEP,
 Directional Couplers and Window from Spinner
- Measured Pulse-to-pulse jitter:
- < 0.02° (phase), < 0.019% (amplitude)

Beam Envelope:

Comparison with 3D particle tracking code (OPAL)

(90% core emittance removes 10% of the bunch charge in head and tail)

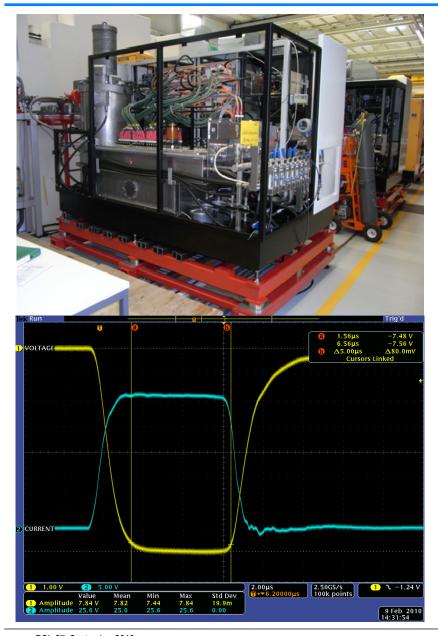
Modulator Commissioning for SwissFEL Injector

For e-gun rf-plant:

- Solid State Modulators from ScandiNova K2-1L, Model 007174
- 265kV, 262A pulse of 5µs duration 10-100Hz
- Pulse Stability < 0.04%
- Dimensions: 2.8 x 1.7 x 2m

- Mechanical support structure had to be reinforced
- Radiation shielding had to be improved
- Oil tank had leak and had to be glued
- Control system blocks from time to time and requires hard-reset of modulator
- Oil-pump gets hot and has to be replaced
- Harmonic distortion on power line has to be improved

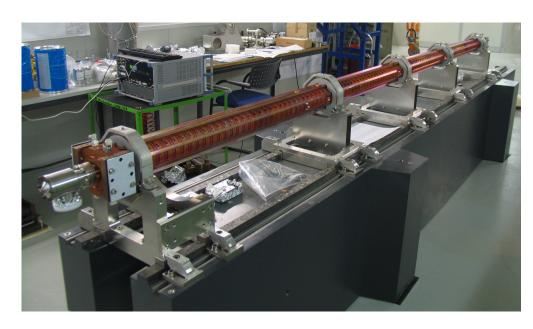
Structure Commissioning for SwissFEL Injector

- Structure from RI (former ACCEL) based on PSI design
- Wave guide splitter and 180°-bend from IHEP
- Waveguide components, directional couplers from MEGA
- Loads and windows from CML

Parameters:

Total length	4150 mm	
Iris diameter	9.31-13.243 mm	
Number of cells	122	
Cell period	33.333 mm	
Operating frequency (40°C)	2997.912 MHz	
Phase advance	2π/3	
Nominal gradient	20 MV/m	
Nominal input power	36.5 MW	
Fill time	0.955 µs	
Operating temperature	38-42°C

- 1 structure broken during tuning.
- ➤ Has been replaced.
- Input coupler of 3 structures had to be retuned to match input impedance
- 2 structures conditioned up to 35MW, 1.5µs, 10Hz
